Summary of Findings

**Coachman Creek Condominium Association, Inc.
Buildings 1 through 28
2625 State Road 590
Clearwater, FL 33759
Claim Number: 4160072**

STRUCTURAL ENGINEERING AND INSPECTIONS, INC.

June 13, 2023

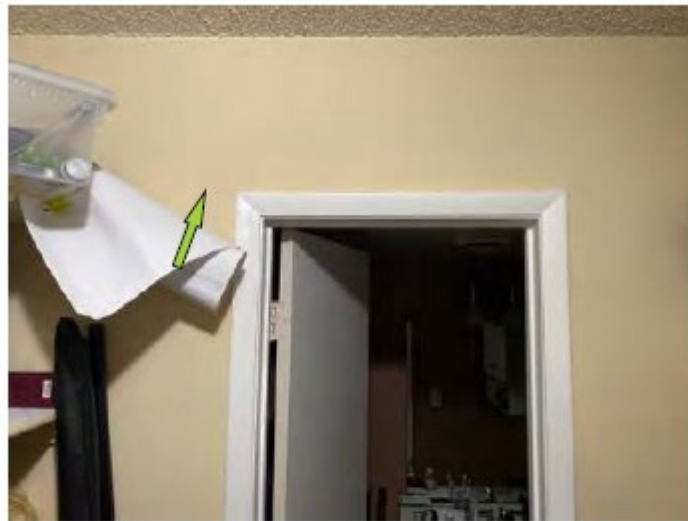
Photograph 135 Building 21; Unit 2123; Walk-In Closet

Negligible to very slight crack in wall surface originating at door opening

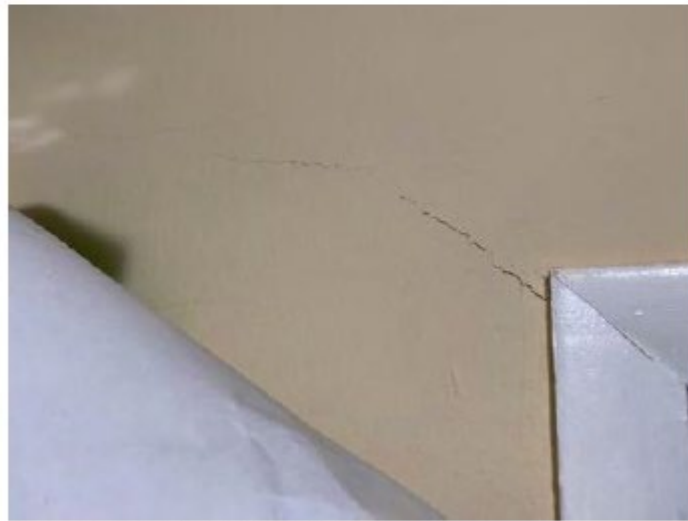
Photograph 136 Building 21; Unit 2123; Walk-In Closet

Alternate view of previous photograph

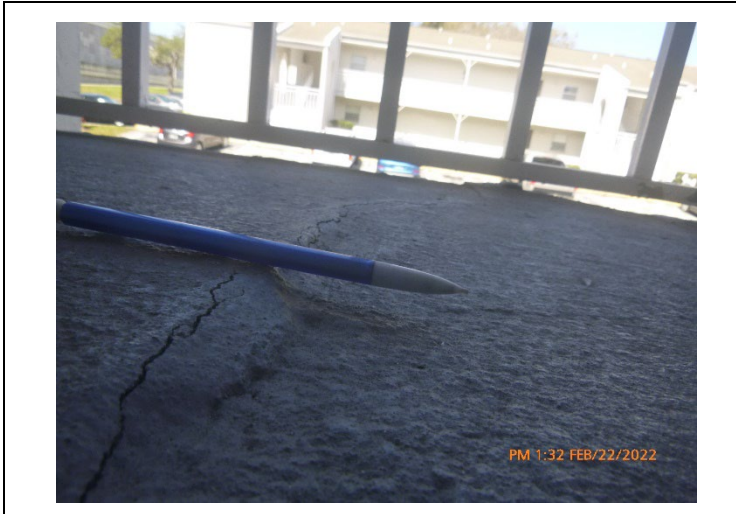
Vertically displaced concrete topping on second floor at Building 5

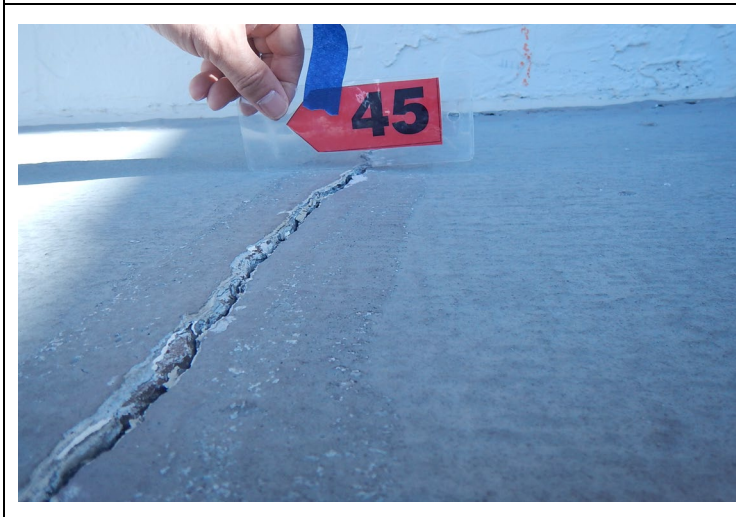
Vertically displaced concrete topping at Building 4

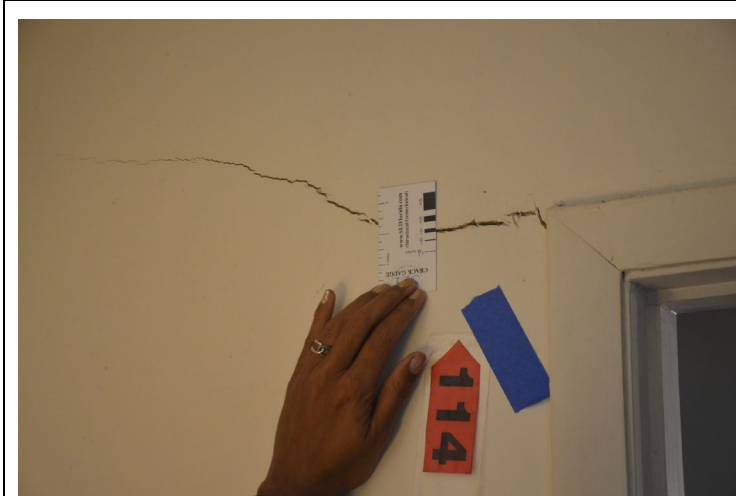
Drywall cracking at Building 4

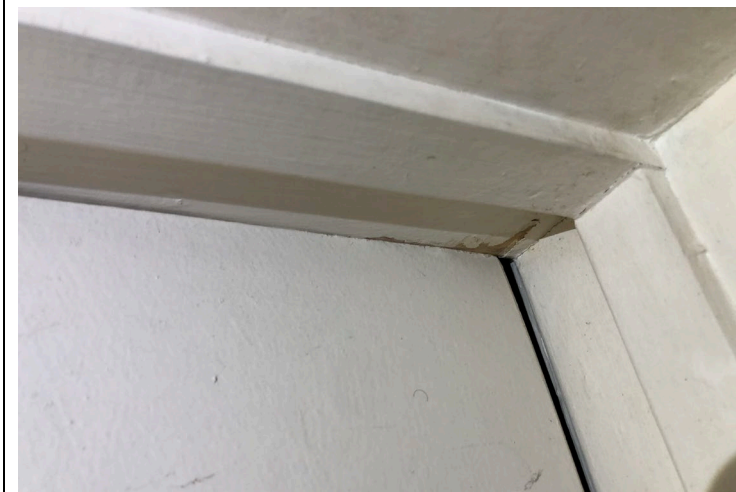
Binding and out-of-square door at Building 4

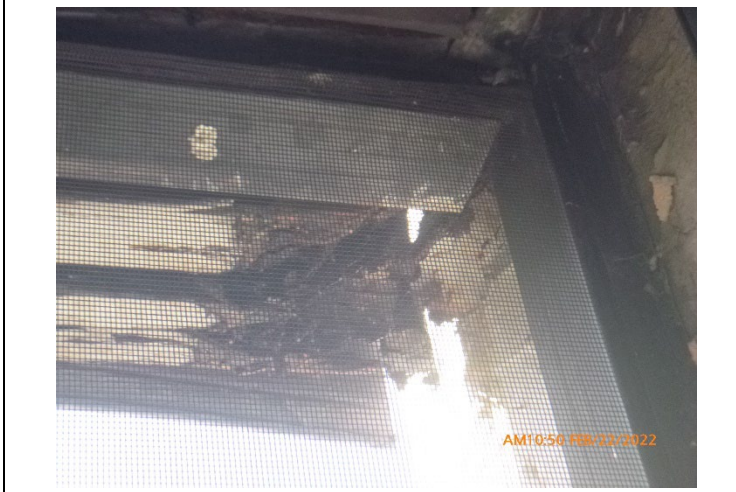
Deteriorated wood beam and
deteriorated/corroded metal hanger at Building 5

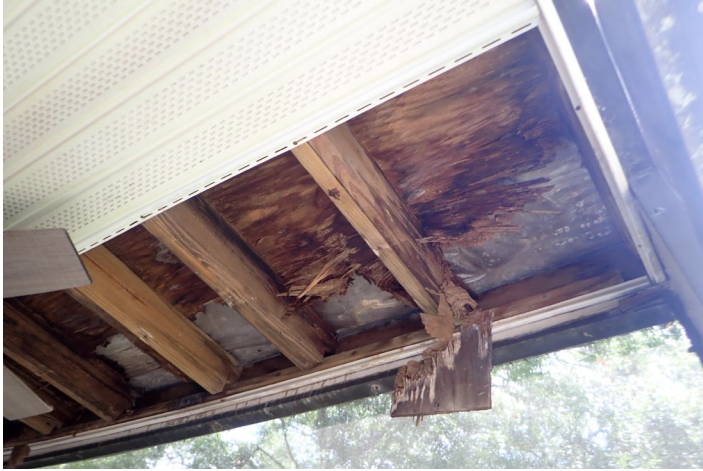
Deteriorated framing at Building 22

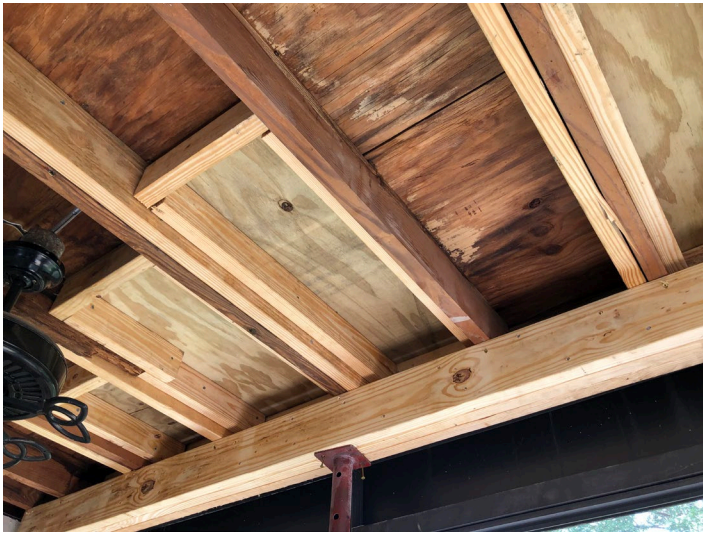
Temporary repairs and shoring to deteriorated framing at Building 22

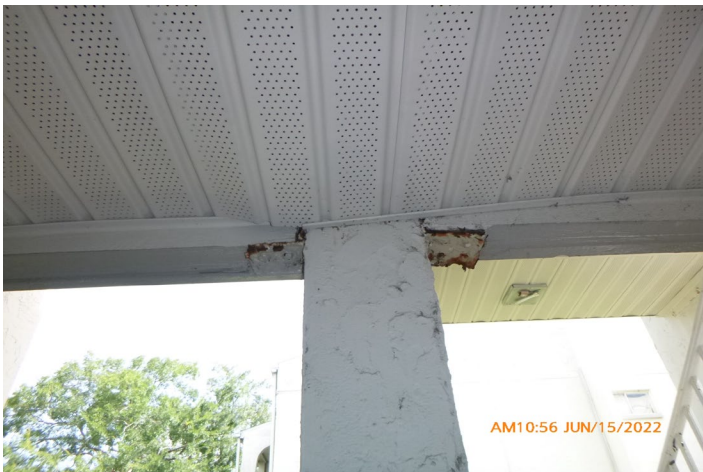
Corroded and distorted metal hangers at Building 19

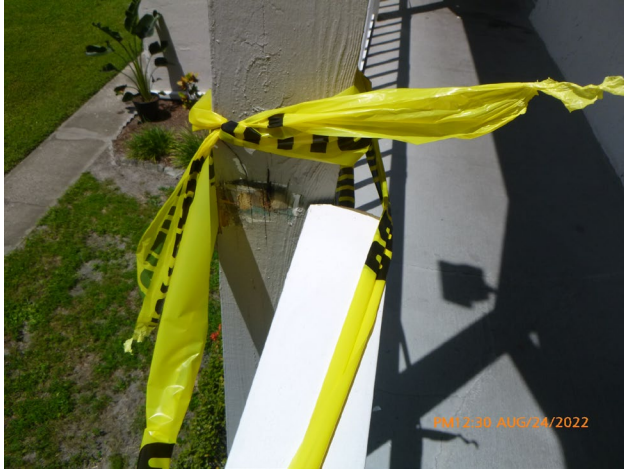
Broken handrail connection at Building 13

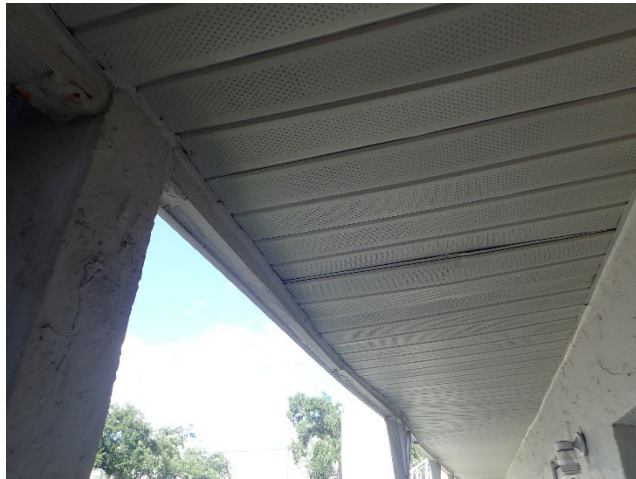
Distorted aluminum soffit at Building 4

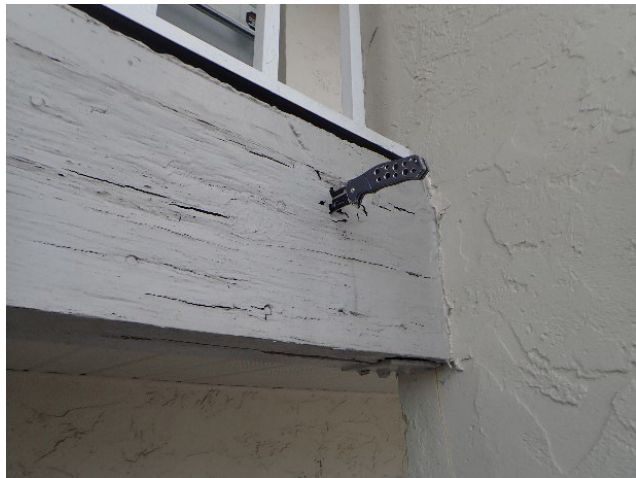
Deteriorated wood beam at Building 12

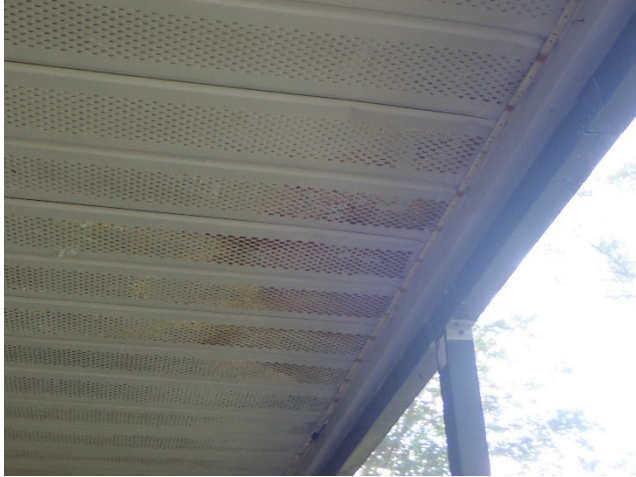
Apparent water intrusion/staining at aluminum soffit at Building 24

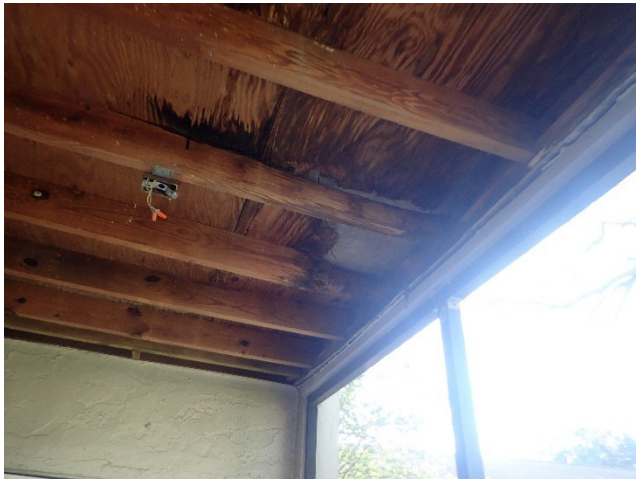
Underlying deteriorated framing at Building 24 after soffit was removed

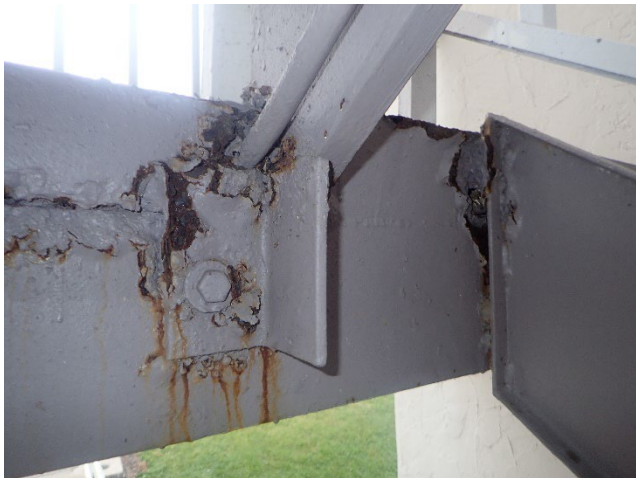
Corroded metal stairs at Building 28

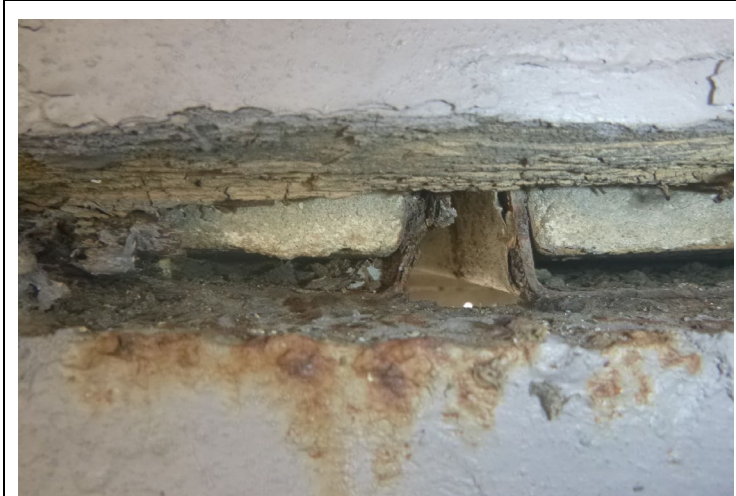
Corrosion and minimal bearing of concrete and metal deck at the stairway landing of Building 11

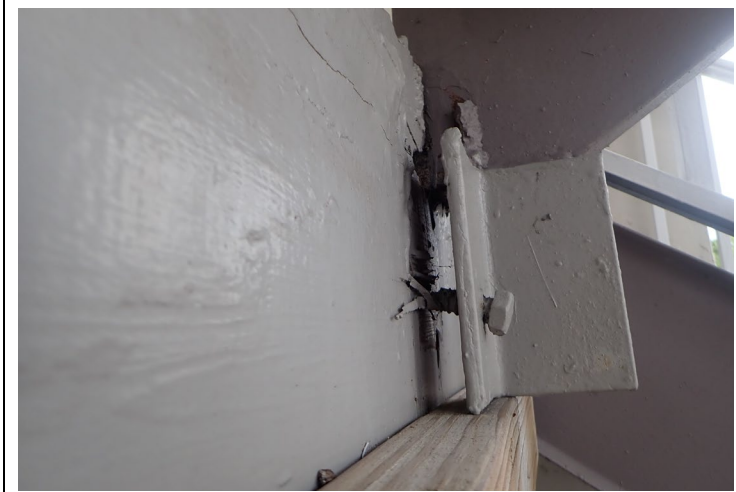
Loose screw at metal stairs of Building 11

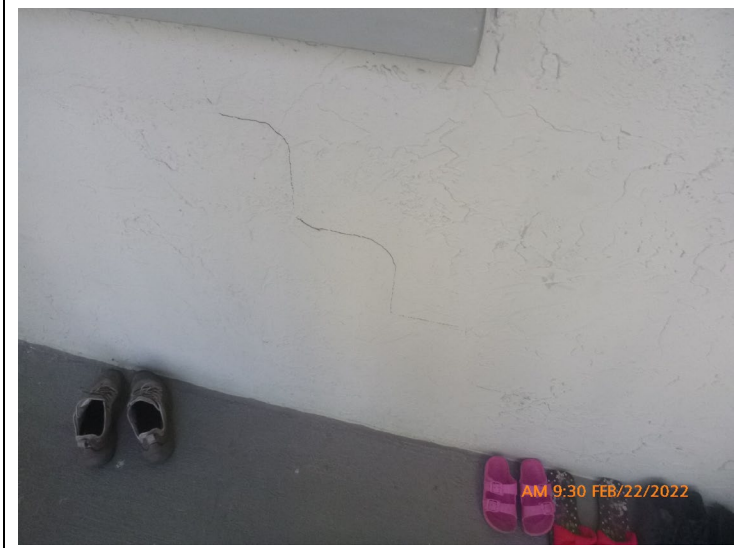
Exterior masonry cracking at Building 5

- e. SEI generally concurs with GWE that structural repairs are required at the masonry walls. This shall include epoxy injection at masonry cracks, possible removal and replacement of masonry components, and/or retrofit filled cells.

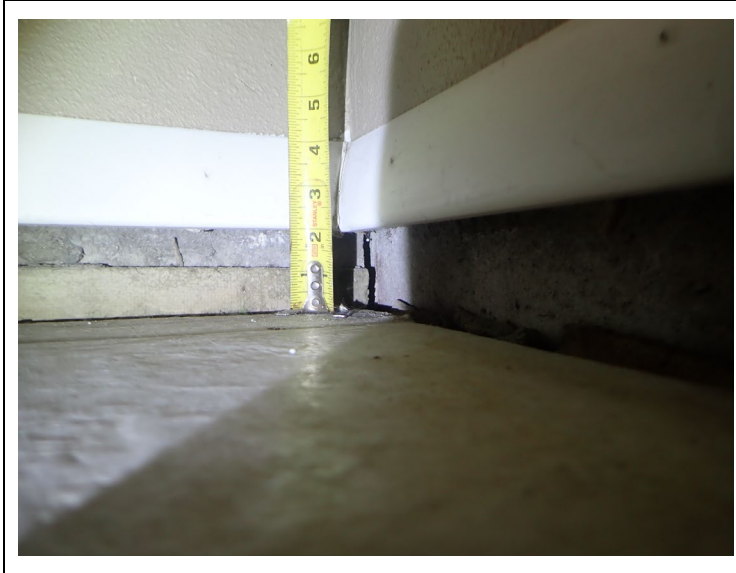
Approximate 2-inch separation of interior concrete floor slab from baseboard at Building 28

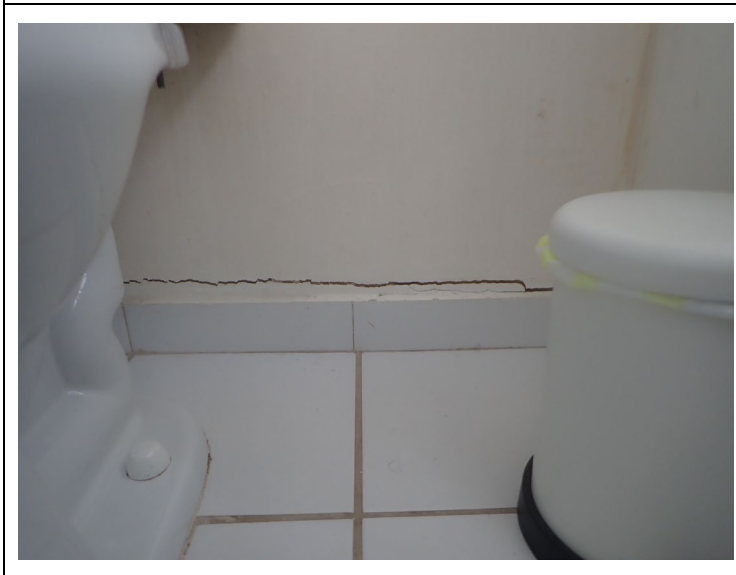
Interior drywall cracking at Building 24 adjacent to cracking at exterior masonry wall

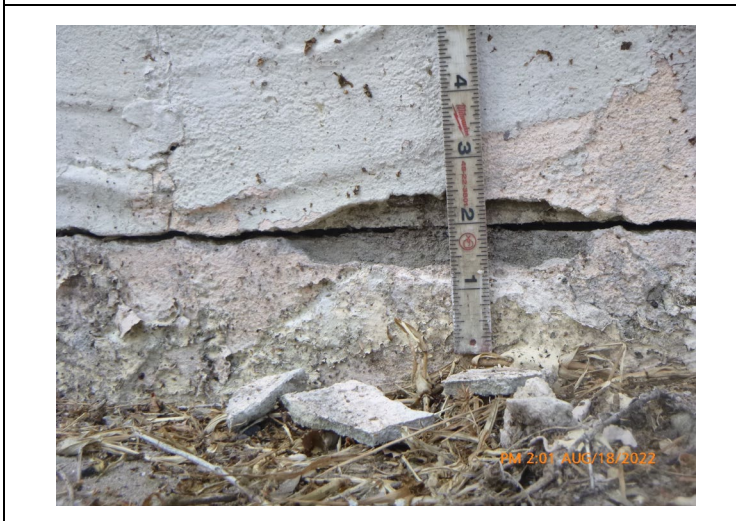
Exterior cracking at masonry wall of Building 24 adjacent to interior drywall cracking
