Summary of Findings

**Coachman Creek Condominium Association, Inc.
Buildings 1 through 28
2625 State Road 590
Clearwater, FL 33759
Claim Number: 4160072**

STRUCTURAL ENGINEERING AND INSPECTIONS, INC.

June 13, 2023

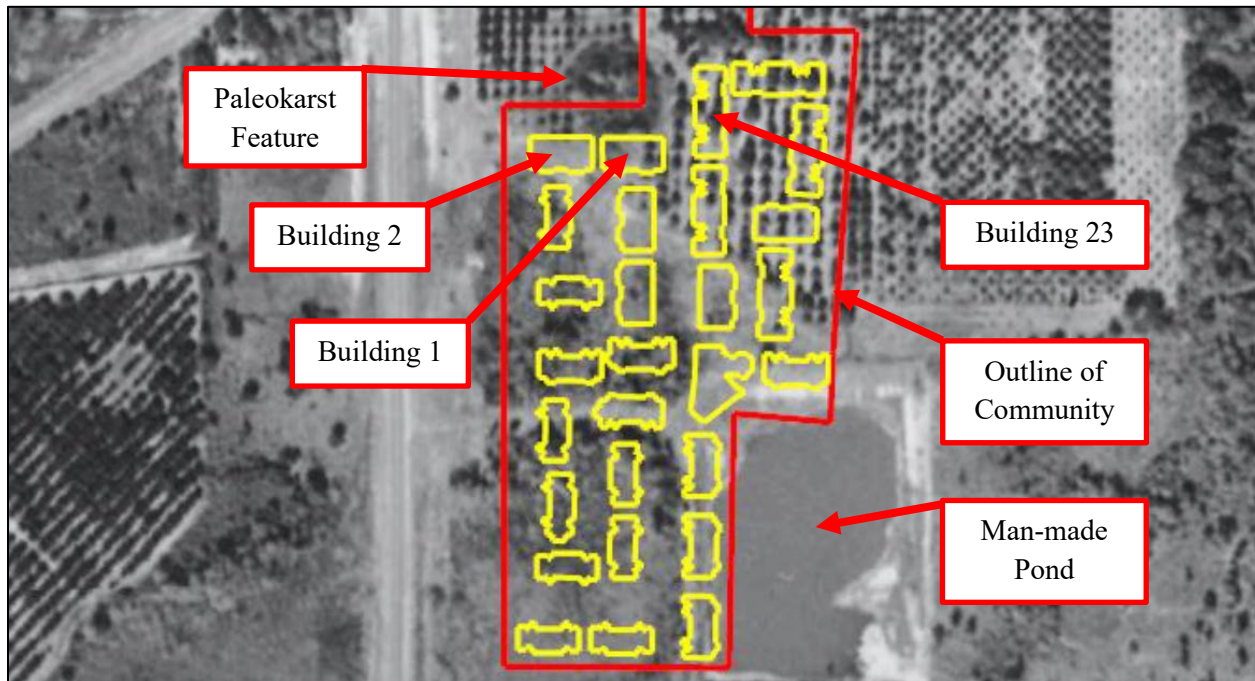
Figure 1 – 1952 Historical Aerial Photograph

- a. Circa 1943, the subject community appeared to have been primarily undeveloped and part of an agricultural area with circular and irregular shaped closed depressional / wetland features in the surrounding area. Particularly, a circular depressional feature reminiscent of a paleokarst feature was located adjacent to Building 1, Building 2, and Building 23. Additionally, the north portion of Building 1 and Building 2 appeared to be overlying the paleokarst feature, as shown in the 1952 historical aerial photograph below in **Figure 1**.

- b. In the 1952 aerial, as shown in **Figure 1**, it appears that a man-made pond was created at the southeast portion of the property.
 - c. In 1962, it appears that most of the vegetation was removed in the northern section of the property in preparation for residential development.

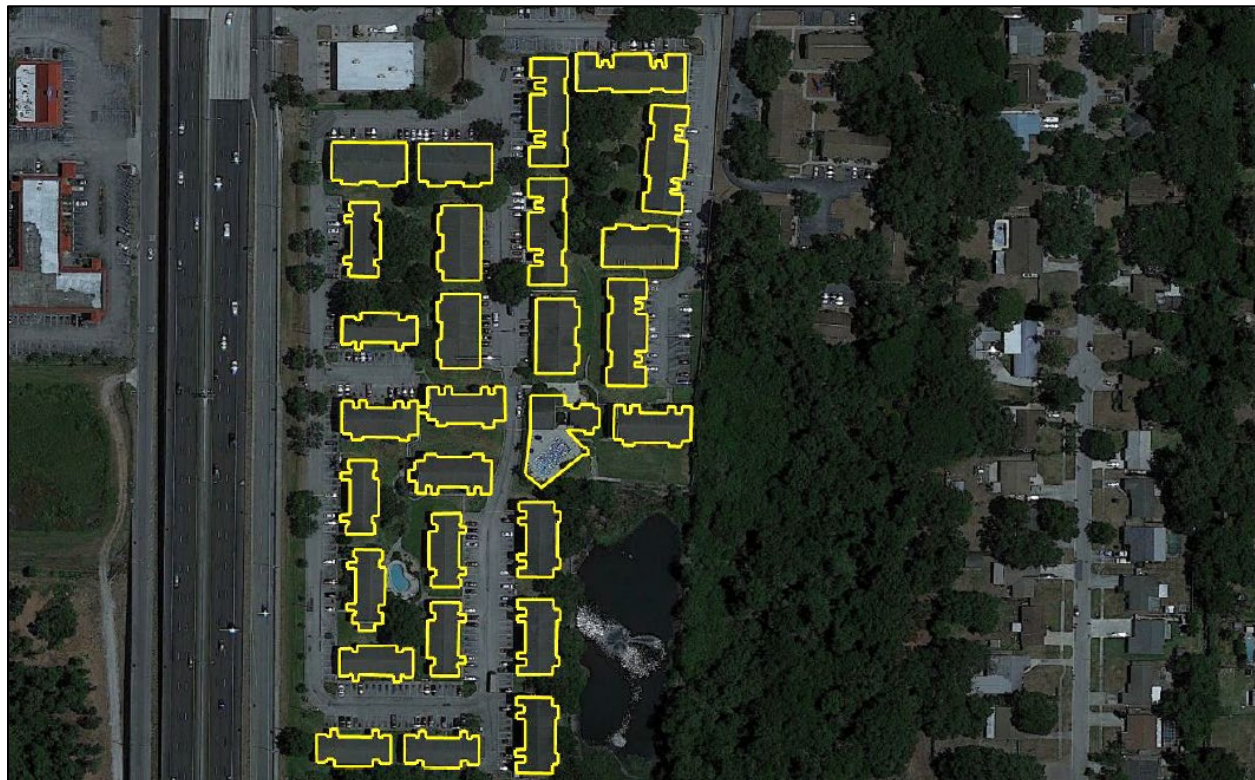
Figure 2 - 2021 Aerial Photograph

- d. By 1976, the site had been fully developed with buildings surrounding the north and west portions of the aforementioned pond and low-lying areas filled in. A relatively current aerial photograph circa 2021 is included in **Figure 2** below for reference.

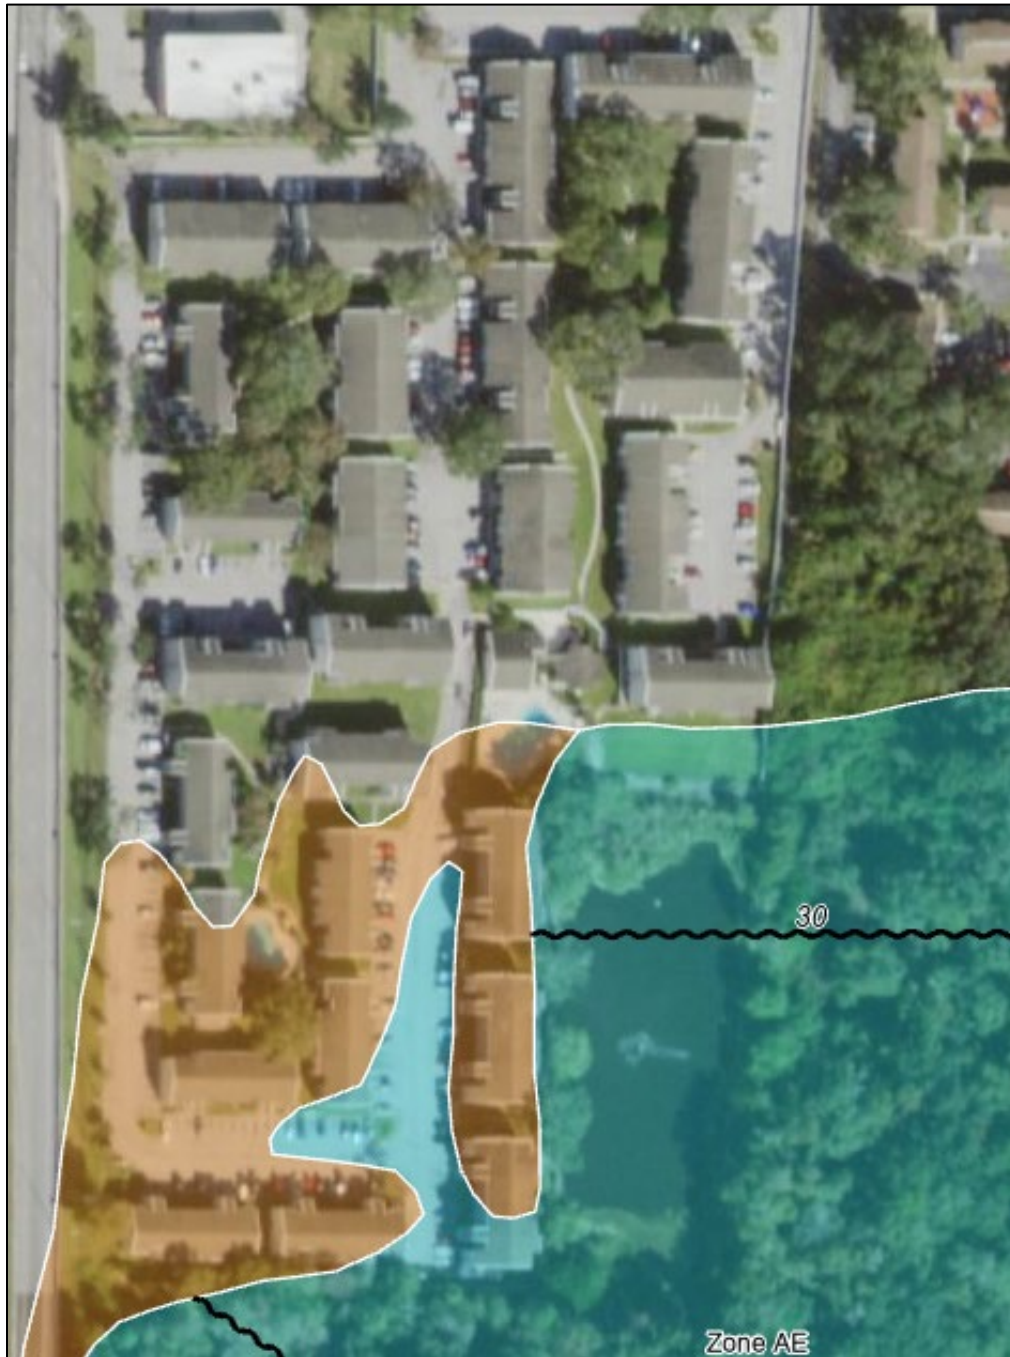
Figure 3 - Excerpt from FEMA Flood Map

A review of the current FEMA flood map indicates that several of the buildings on the south end of the property are located in a FEMA special flood hazard area AE (blue area) or flood zone X (orange area). Buildings 9, 10, 11, 12, and 15 appear to be located in zone AE. Buildings 7, 8, 14, and 16 appear to be located in zone X.
